6L80E: Tool Necessity

Also needed for servicing the 6L50E in the Cadillac CTS and the 6L90E in GM 2500 pickups

Center support retaining ring removal:

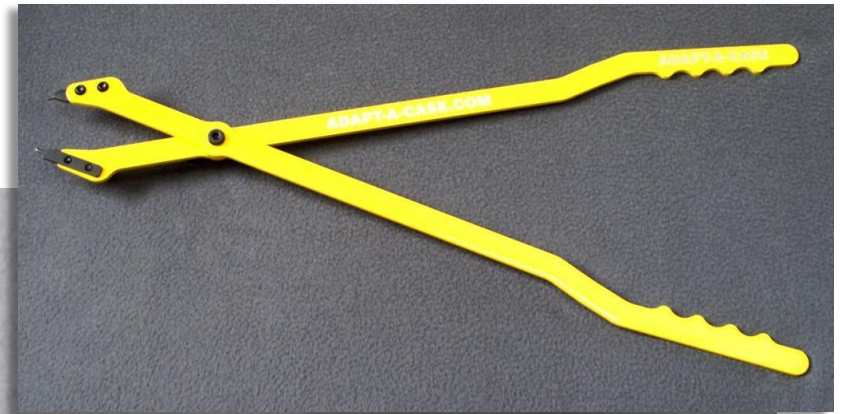
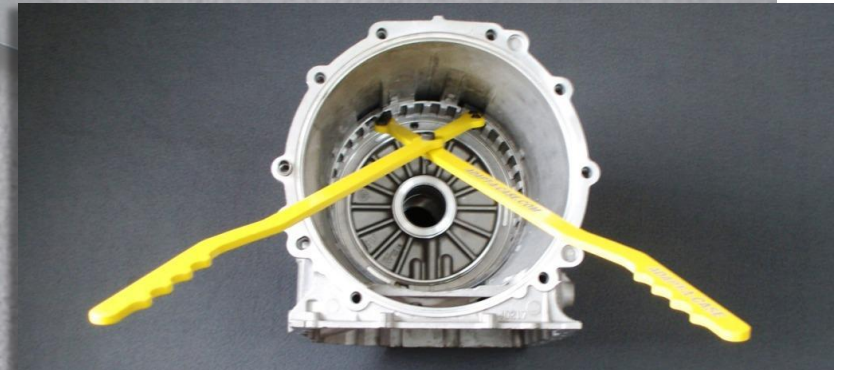
The 6L80E ushered in a new era as GM's rear-wheel drive workhorse. A fascinating design that uses a Lepelletier-inspired gear train; it also uses a large aluminum center support which must be removed to gain access to the low/reverse clutch pack and the rear planet assembly.

The center support houses the 2-6 clutch pack on the front side and the low/reverse on the rear. The size of the support and the amount of stress of the two clutch packs it contains made necessary the use of a rather large, extremely stout snap-ring to hold it firmly in place.

Therefore, a rather large and stout pair of pliers is required! Until just recently none were available. To remove the snap ring many have found it necessary to cut into the case from the bottom to gain access with a screwdriver and hammer to "pop" it out of the groove.

Leverage is the name of the game when this much pressure is in play. The engineers at Adapt-A-Case burned the midnight oil working through many designs before arriving at what you see. The heavy-duty tips are replaceable, available through your regular tool truck.
